FATAL TRAINING FIRES: FIRE ANALYSIS FOR THE FIRE SERVICE

Daniel Madrzykowski
Building and Fire Research Laboratory
National Institute of Standards and Technology
Gaithersburg, Maryland, USA 20899-8661

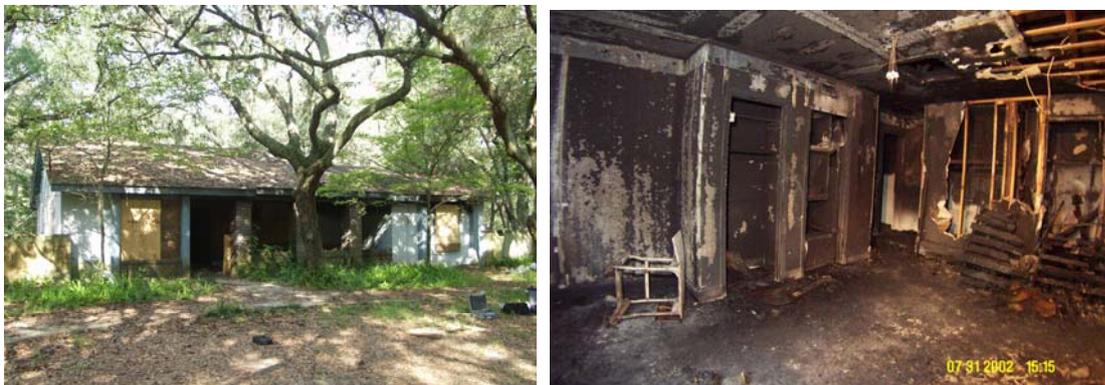
Figure 1. Outside of acquired structure and interior of fire room.

On July 30, 2002 a training evolution resulted in the loss of two firefighters. The training evolution took place in an acquired one-story, single family home in Florida, see Figure 1. A fire load was set-up in and around a closet in the bedroom of the house to provide the heat and smoke conditions needed for the exercise. After a safety briefing and a safety walk through, the trainees went outside the structure to wait for the evolution to begin. The fire was ignited and produced smoke but only small flames. A polyurethane foam mattress was moved from another room in the structure and placed over the fire in the closet. A two man search and rescue (SAR) team entered the building after an indication from one of the four interior safety officers that the smoke conditions were such that the evolution was “ready to begin”³.

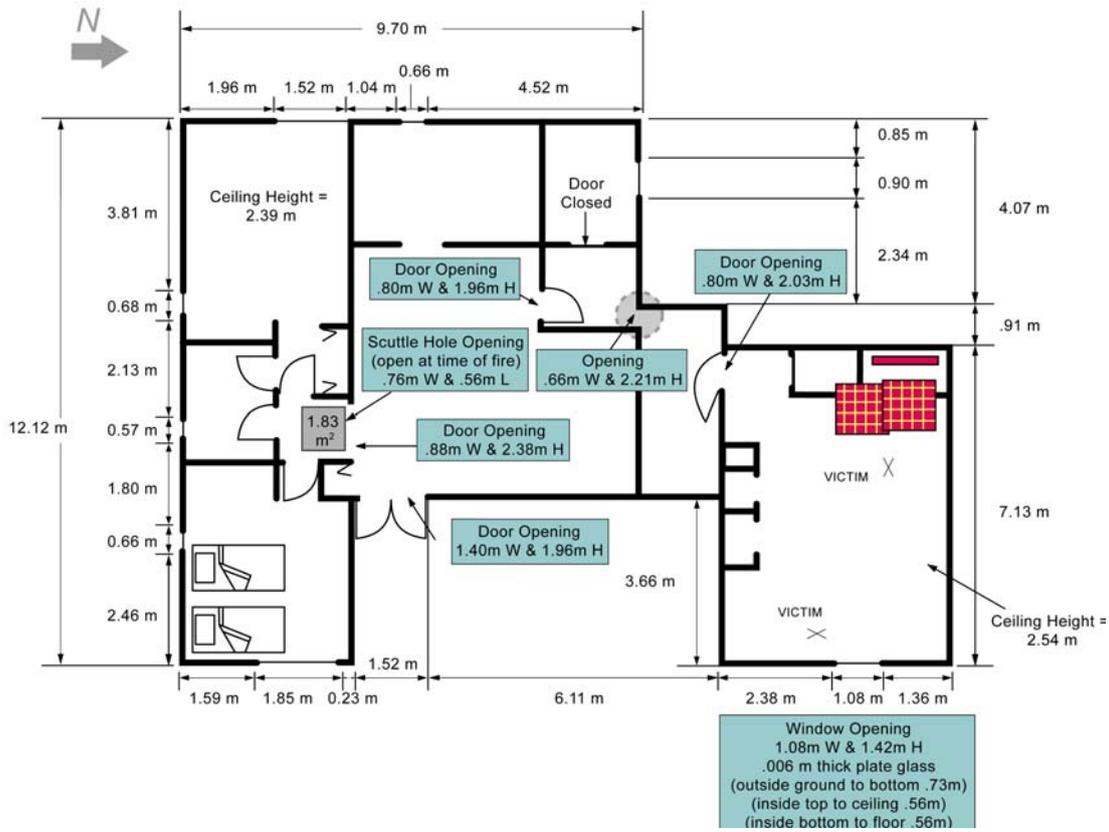
Figure 2. Floor plan of acquired structure

As the fire developed, the smoke inside the structure intensified rapidly and the location of the SAR team could not be determined. Approximately three and a half minutes (210 seconds) after the SAR entered the structure, the window in the fire room was broken out by the outside vent man. Within a short period of time after the window was opened, a flashover occurred and flames were extending out of the front bedroom window. Personal Accountability Reports (PARs) were called and the RIT was activated to locate the SAR team. As the fire was being suppressed by the second hose crew, the building evacuation signal was sounded, since the SAR crew had not been located. Shortly, after the fire was extinguished the bodies of the firefighters from the SAR crew were discovered in the fire room. A floor plan of the structure is shown in Figure 2. The approximate location of the victims is also shown^{8,9}.

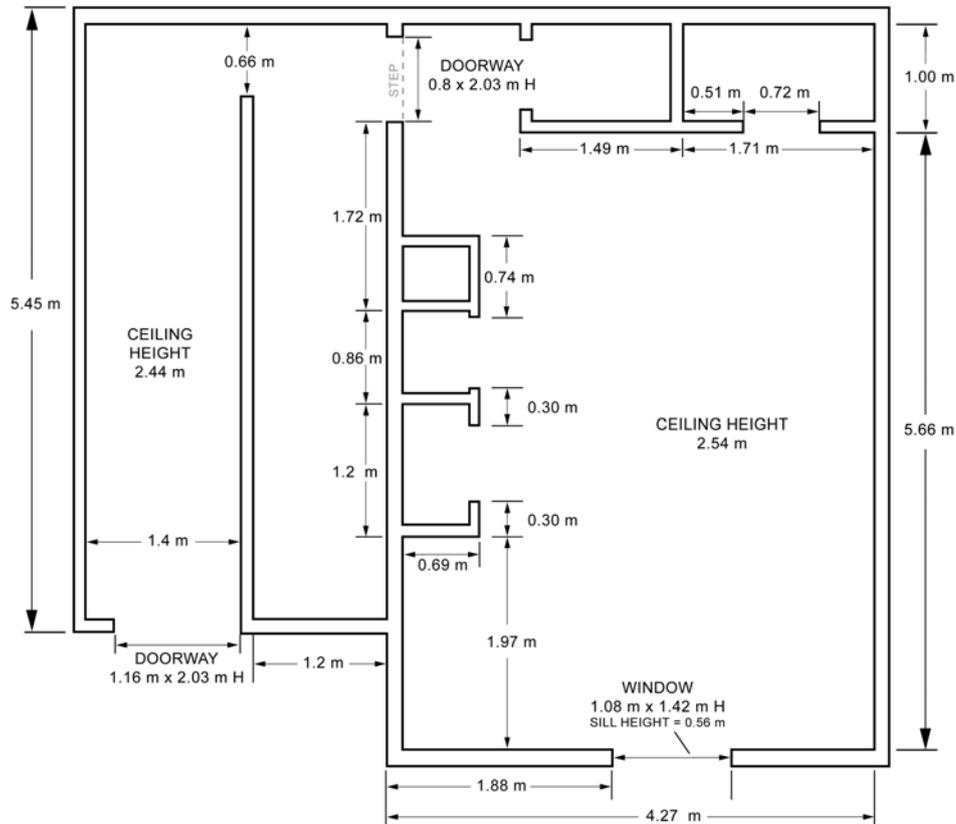
Figure 3. Plan view schematic of full-scale experimental arrangement

NIST was asked by FSFMO and NIOSH to analyze the fire conditions. NIST staff visited the acquired structure, documented the geometry and photographed the fire damage. NIST worked with the FSFMO and NIOSH to construct a timeline of the incident. A re-creation of the fire room and two adjoining spaces was built in the NIST Large Fire Test Facility. The experimental arrangement is shown in Figure 3. The walls of the structure were framed with wood members nominally 51 mm by 102 mm. The ceiling support structure was composed of engineered wood I beams.

The wall and ceiling framing was covered with a double layer of 13 mm thick gypsum board to form the interior walls and ceiling of the test structure. The second layer of gypsum board was installed with the joints between sheets at 90 degree angles to the joints or seams of the 1st layer. The gypsum board joints were spackled and then painted with interior latex paint.

In the fire room wood trim was added around the opening of the closets and the baseboard trim around the room. A 6 mm thick plate glass window was installed with a wood support frame in the front of the test room.

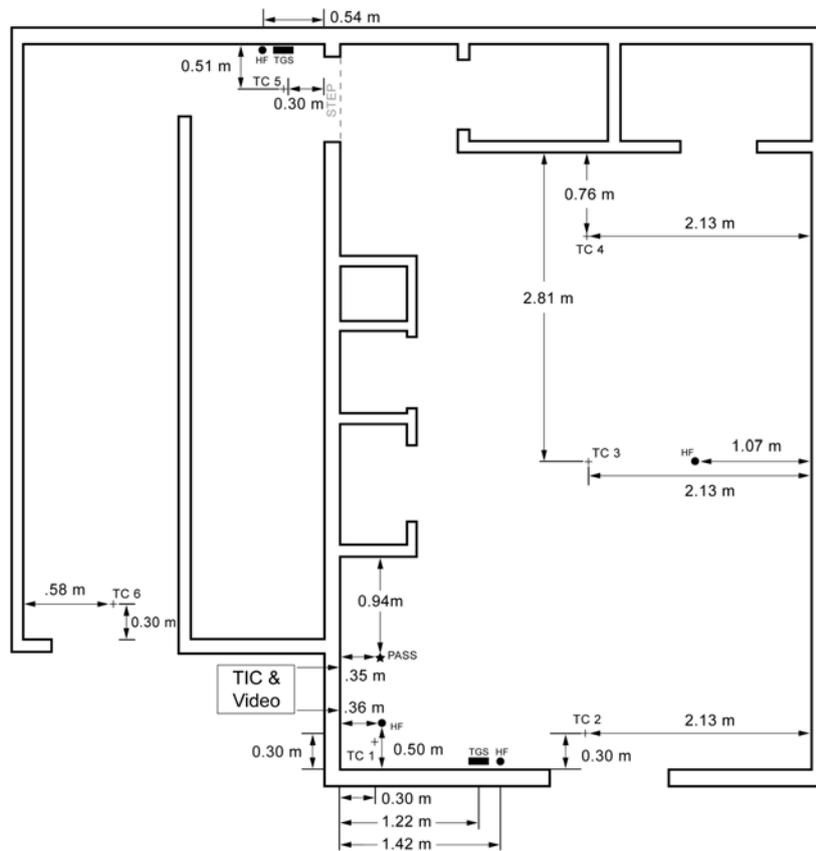
The experiment was instrumented with thermocouples, heat flux gages, video and thermal imaging cameras (TICs) as shown in Figure 4. Each thermocouple array was composed of Type K, 0.25 mm barebead thermocouples positioned at 0.030 m, 0.305 m, 0.610 m, 0.915 m, 1.22 m, 1.53 m, 1.83 m, 2.14 m, and 2.44 m below the ceiling. The heat flux sensors were positioned at approximately 1 m above the floor. The sensing surface of one in each pair was looking up at the ceiling and the other sensing surface was vertical, aimed at the pallets on the south wall.

Figure 4. Instrumentation arrangement.

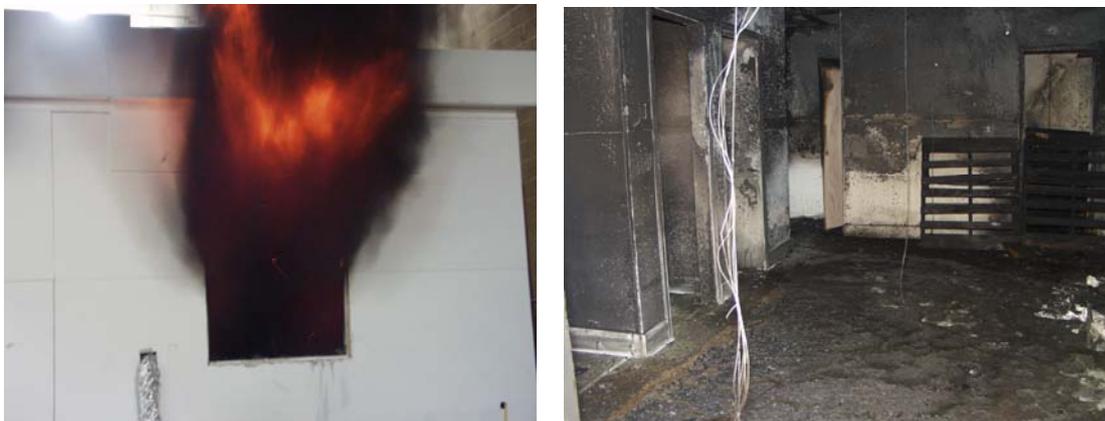
Figure 5. Test 2, exterior view of fire room during flashover and post test interior of fire room.

Each of the five experiments resulted in flashover, although changes in the fuel load and ventilation did provide differences in the time to flashover and if allowed to burn for an extended period it appears would have made a difference in the period of post-flashover full room involvement.

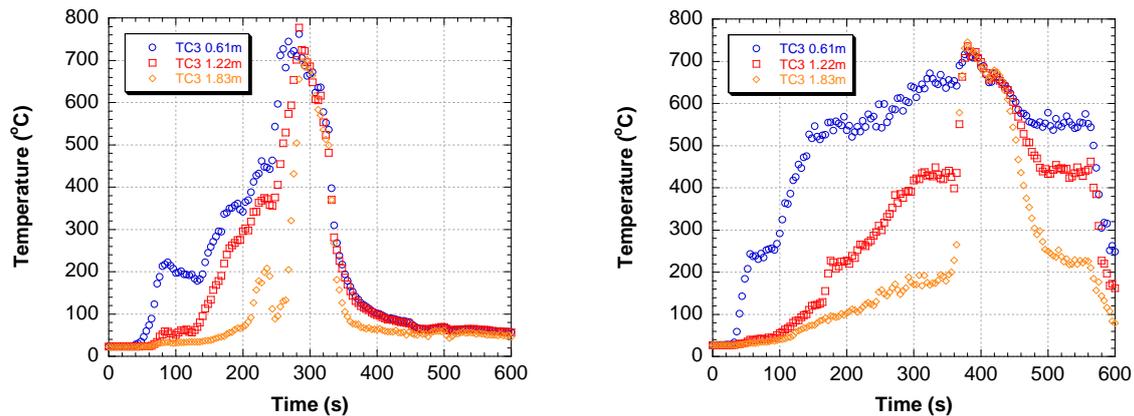
Figure 6. Temperature histories from Test 2 and Test 5 at the TC Array 3 position in the center of the fire room. TC positions at 0.61, 1.23 and 1.83 m below the ceiling are shown.

The data shown in Figure 6 represents temperature results from the tests with the largest difference in fuel loading, Test 2 on the left and Test 5 on the right. In Test 2, the window is opened at approximately 240 s. The entrainment of fresh air cools the thermocouple located at 1.83 m below the ceiling. The fresh supply of oxygen to the ventilation limited fire enables flashover to occur within the next 40 seconds. The fire was suppressed with water approximately 30 seconds after flames were observed coming out of the open window. In Test 5, no synthetic fuel was used and the window was opened prior to ignition. These changes delayed the onset of flashover by approximately 90 seconds as shown in the graph. Suppression of the fire was not initiated in Test 5 until 570 s after ignition, because post-flashover, the combustion zone began to reduce in volume to just flames that were attached to the fuels in the area of origin and on portions of the floor, as opposed to continued full room involvement.

In all of the tests, conditions were un-tenable for a firefighter in full Personal Protective Equipment (PPE) to remain in the room. Temperatures in excess of 260 °C and heat fluxes in excess of 20 kW/m² suggest that survival time would be limited to less than 30 s^{10,11}.

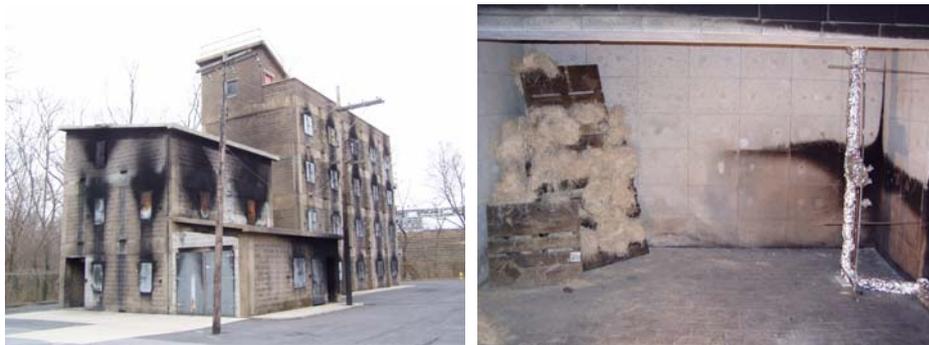
The residential burn building is a three story structure above grade, with a basement, below grade, Figure 7. The exterior plan dimensions of the building are 11.0 m by 7.9 m. The first level is composed of 4 rooms and a garage area. An interior stair provides access to the basement and the second floor. The area of the second floor is approximately 7.5 m by 7.5 m. The second floor has two rooms, a hallway and interior stair access to the third floor. The third floor is designed as an open attic area with an sloped ceiling. The basement area has an “L” shaped hallway with a burn room inside the “L”. The interior stair leads to the basement at one end of the hallway and a stair that leads to the exterior is on the opposite end of the “L” shaped hallway. The floor plan for the basement is provided in Figure 8.

Figure 7. Exterior of residential fire training building and basement burn room.

The building is supported with reinforced concrete columns and beams. The floors and ceilings are concrete. Most of the interior walls within the structure are composed of cement block. These walls are not load-bearing. Areas in the building where training fires are conducted, have been protected with a 25 mm thick layer of calcium silicate insulation, which is covered by a 50 mm thick concrete tile. Significant portions of the basement are protected with these materials. The north and east wall and the ceiling of the basement burn room are covered. A portion of the south wall and the hallway ceiling outside the room are also covered. The floor of the burn room is protected with fire brick. All of the training evolutions/experiments for this series of measurements were conducted in the basement.

The ventilation to the basement is limited to the doorway at the top of the interior stair, the doorway at the top of the exterior stair and a window opening from the basement hallway that opens directly to the outside. There is only one doorway in the burn room. The doorway is 1.9 m tall by 1.0 m wide. There is no direct ventilation from the burn room to the outside.

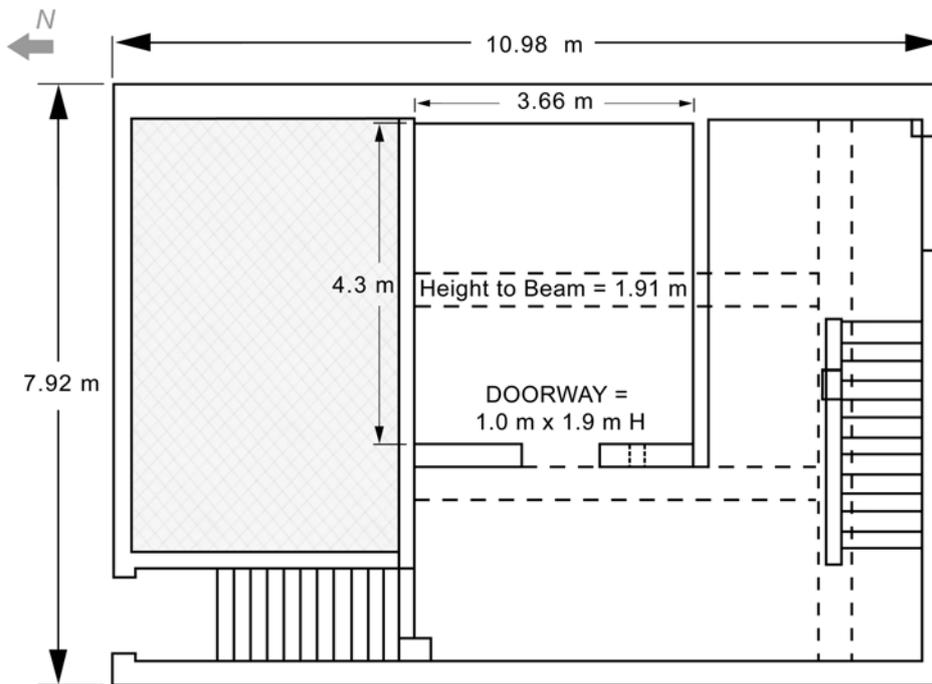
Figure 8. Plan view schematic of full-scale experimental arrangement

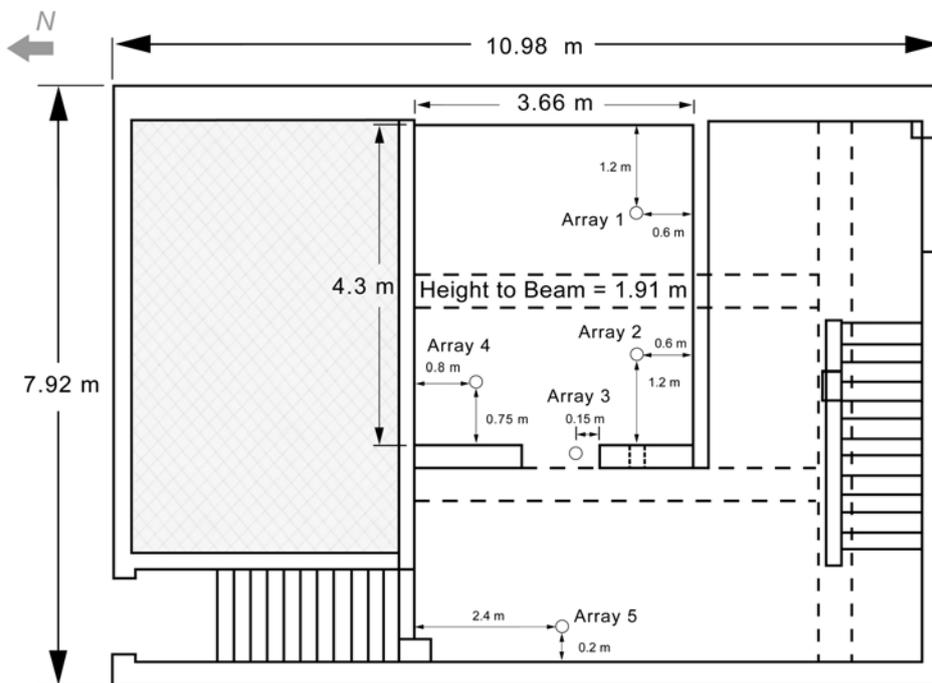
The experiments were instrumented with thermocouples, heat flux gages, video and thermal imaging cameras (TICs) as shown in Figure 9. Each thermocouple array was composed of Type K, 0.25 mm, barebead thermocouples positioned at 0.03 m, 0.305 m, 0.610 m, 0.915 m, 1.22 m, 1.53 m, 1.83 m, and 2.14 m below the ceiling. The heat flux sensors were water cooled Schmidt-Boelter type transducers. Seven of the sensors were positioned at approximately 1.5 m below the ceiling. The sensing surface of one in each pair at Arrays 1,2 and 5 were looking up at the ceiling and the other sensing surface was vertical, facing the fire area in the NE corner of the burn room. An additional heat flux gage was installed at 0.610 m below the ceiling in Array 1 and facing north.

Figure 9. Instrumentation arrangement.

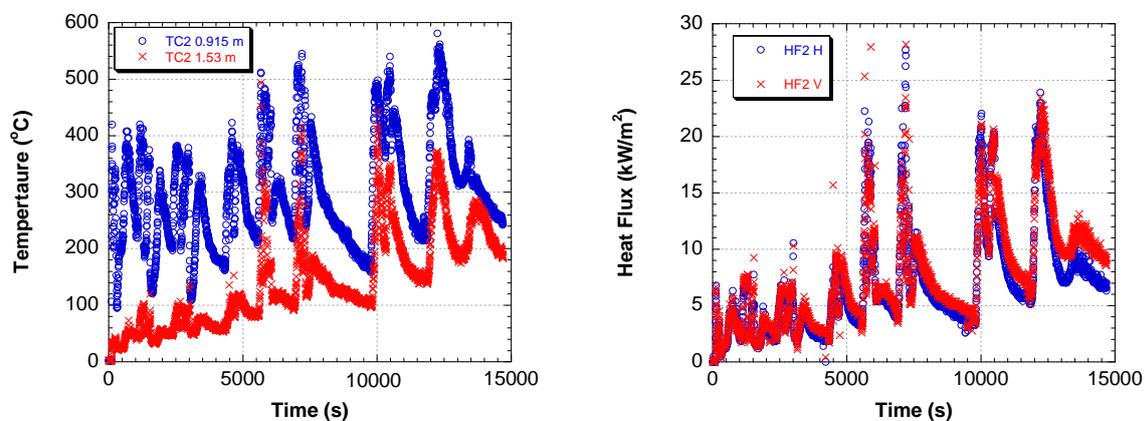
Figure 10 presents graphs of the temperature and the total heat flux time histories for the eight evolutions. The peak temperatures and heat fluxes for the final four evolutions are significantly higher and more distinct than those for the first four evolutions. Perhaps the most important data to notice from the graphs is not the peak temperatures and heat fluxes but the temperatures and heat fluxes that exist in the room at the start of each evolution. These were the time periods when the instructor was in the burn room loading the pallets for the next evolution. As part of the standard operating procedure, only instructors are allowed in the burn room and only for brief periods to re-supply the fuel load. Due to energy stored in the walls, ceiling and floor of the room, the ambient room temperatures and heat flux measurements kept increasing with each additional burn. By the time the last evolution was ready to start at 11700 s (3.25 hrs.), the temperature at 1.53 m below the ceiling was approximately 150 °C and the heat flux was approximately 6 kW/m². Given that the instructor would be carrying pallets into the room, the thermal exposure to the upper body would be higher. At 0.91 m below the ceiling the residual temperature is in excess of 200 °C in the corner of the burn room most remote from the fire.

Figure 10. Temperature and heat flux time histories for all eight experiments. The data shown was from Array 2, TC positions at 0.915 and 1.53 m below the ceiling and HF positions approximately 1.5 m below the ceiling.

four hours. The data were recorded at 4 second intervals. Graphs of the entire time history of thermocouple channels at the most remote position in the burn room from the fire at locations 0.915 m and 1.53 m below the ceiling is shown in Figure 10 along with the graphs of the total heat flux sensors also in Array 2, at approximately 1.5 m below the ceiling.
